BRIDGE DAMAGE AND RECONSTRUCTION FROM TOHOKU REGION PACIFIC COAST EARTHQUAKE

Nobuya KAWATA^a, Yasushi TAKAHASHI^b, Mitsuru SUGIYAMA^b, Tomohiro OBUCHI^b

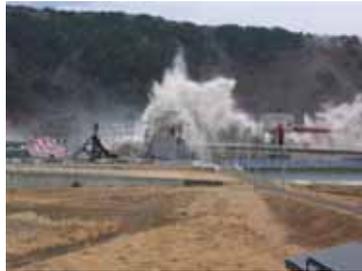
The bridge was subjected to the tsunami waves directly, as shown in photo 1. And the waves crashed on the dam downstream and splashed. The superstructure did not fall down due to decreasing of the tsunami wave energy. However the railing was extremely distorted outward, as shown in photo 2.

Photo 1 : Tsunami waves

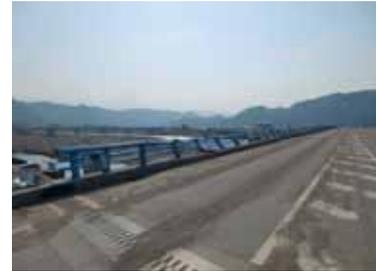
Photo 2 : Railing damage

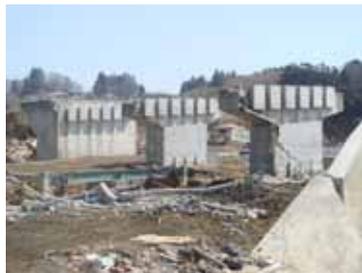
The bridge was consisted of the several post-tension simple T-beams. All superstructure fell down by the tsunami wave, as shown in photo 3. The superstructure was attached to the substructure with the anchor bars, as shown in figure 2. Because the anchor bars were found to be still straight after the disaster, it is considered that the superstructure was moved up by the buoyancy and then was washed away by the flowing water pressure.

Photo 3 : Numata bridge

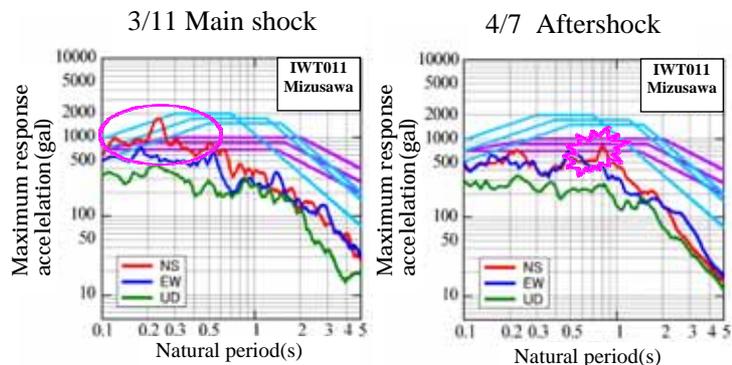
Figure 3: Response acceleration spectrum

Figure 3 shows the response acceleration spectrum which were using the seismic wave recorded near two bridges. The response acceleration spectrum of the main-shock is high in the short-period range. While, in the case of the aftershock, the peak is at 0.8 seconds which is similar to the natural period of two bridges. It is considered as the cause of the damages of two bridges.

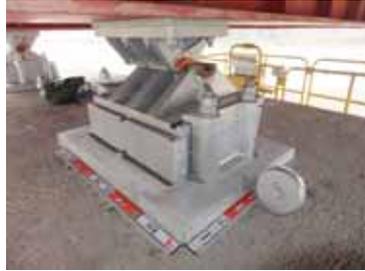
Fuji Bridge is shown in photo 4. The pin bearings were broken by the aftershock and the pins dropped as shown in photo 5. In the piers of this bridge, a tensile yield of the longitudinal reinforcement and the compression failure of concrete were observed at the upper part of the section where the amount of reinforcement was changed, as shown in photo 6 and 7.

Photo 5 : Bearing failure

To obtain the emergency transportation, a temporary repair work was carried out for the bearing. The time efficiency is important in reconstruction. Therefore, the method using shaped steel was adopted as shown in photo 8.

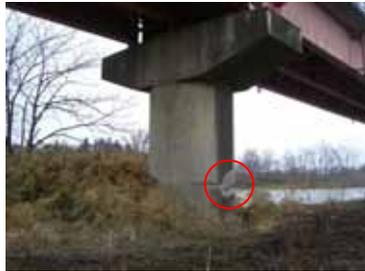
Photo 6 : Pier damage

In the reconstruction of the piers, to avoid the damaged portion from slip by possible aftershocks, the method of restraining the H-section steels around the piers by the wire was adopted. Situation and detail of the reconstruction were shown in the photo 9 and figure 4 respectively.

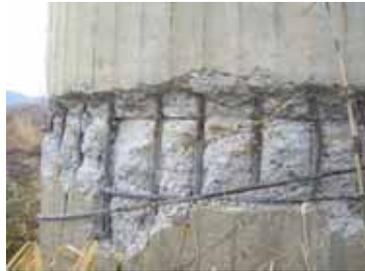
Photo 7 : Flexural failure

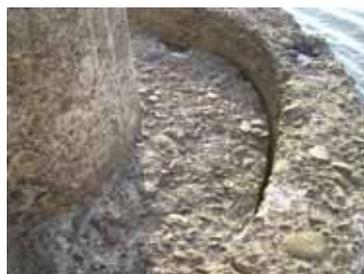
Koyagi Bridge is shown in photo 10. Since the top slab of the bridge foundation with open-caisson sagged and tilted, the column of the bridge tilted to the downstream side as shown in Photo11 and figure 5. The deformation of the railing as shown in photo 12 was caused by the displacement of foundation.

Photo 11 : Caisson damage

To confirm the possibility that the displacement progresses by the various factors including the traffic load and the possible aftershocks, the cause of the foundation displacement (e.g. top slab sagging) was investigated prior to reconstruction. As a result of the investigation, some voids under the top slab, passing-through cracks of the top slab, and 1 meter scouring were found. Since the result showed there was a possibility that the further displacement occurs, reconstruction was carried out as shown in figure 6.

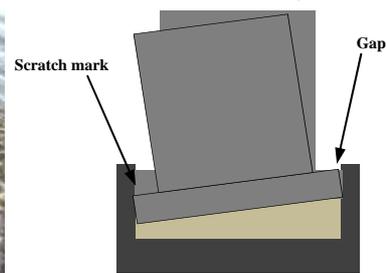
Figure 5 : Damage situation

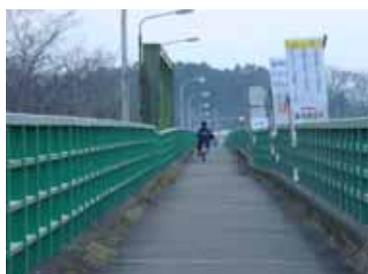
Photo 12 : Railing damage
