BRIDGE DAMAGE AND RECONSTRUCTION FROM TOHOKU REGION PACIFIC COAST EARTHQUAKE

Nobuya KAWATA^a, Yasushi TAKAHASHI^b, Mitsuru SUGIYAMA^b, Tomohiro OBUCHI^b

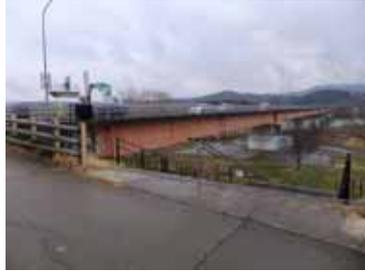
Photo 4 : Fuji Bridge

Fuji Bridge is shown in photo 4. The pin bearings were broken by the aftershock and the pins dropped as shown in photo 5. In the piers of this bridge, a tensile yield of the longitudinal reinforcement and the compression failure of concrete were observed at the upper part of the section where the amount of reinforcement was changed, as shown in photo 6 and 7.

To obtain the emergency transportation, a temporary repair work was carried out for the bearing. The time efficiency is important in reconstruction. Therefore, the method using shaped steel was adopted as shown in photo 8.

In the reconstruction of the piers, to avoid the damaged portion from slip by possible aftershocks, the method of restraining the H-section steels around the piers by the wire was adopted. Situation and detail of the reconstruction were shown in the photo 9 and figure 4 respectively.

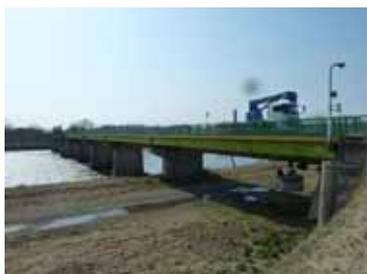
Photo 10 : Koyagi Bridge

Koyagi Bridge is shown in photo 10. Since the top slab of the bridge foundation with open-caisson sagged and tilted, the column of the bridge tilted to the downstream side as shown in Photo11 and figure 5. The deformation of the railing as shown in photo 12 was caused by the displacement of foundation.

To confirm the possibility that the displacement progresses by the various factors including the traffic load and the possible aftershocks, the cause of the foundation displacement (e.g. top slab sagging) was investigated prior to reconstruction. As a result of the investigation, some voids under the top slab, passing-through cracks of the top slab, and 1 meter scouring were found. Since the result showed there was a possibility that the further displacement occurs, reconstruction was carried out as shown in figure 6.
